Phillips 66 Fire & Explosion

Robert M. Bethea
Texas Tech University

Houston Chemical Complex
Pasadena Texas
October 23, 1989

Fire and Explosion in PE Reactor

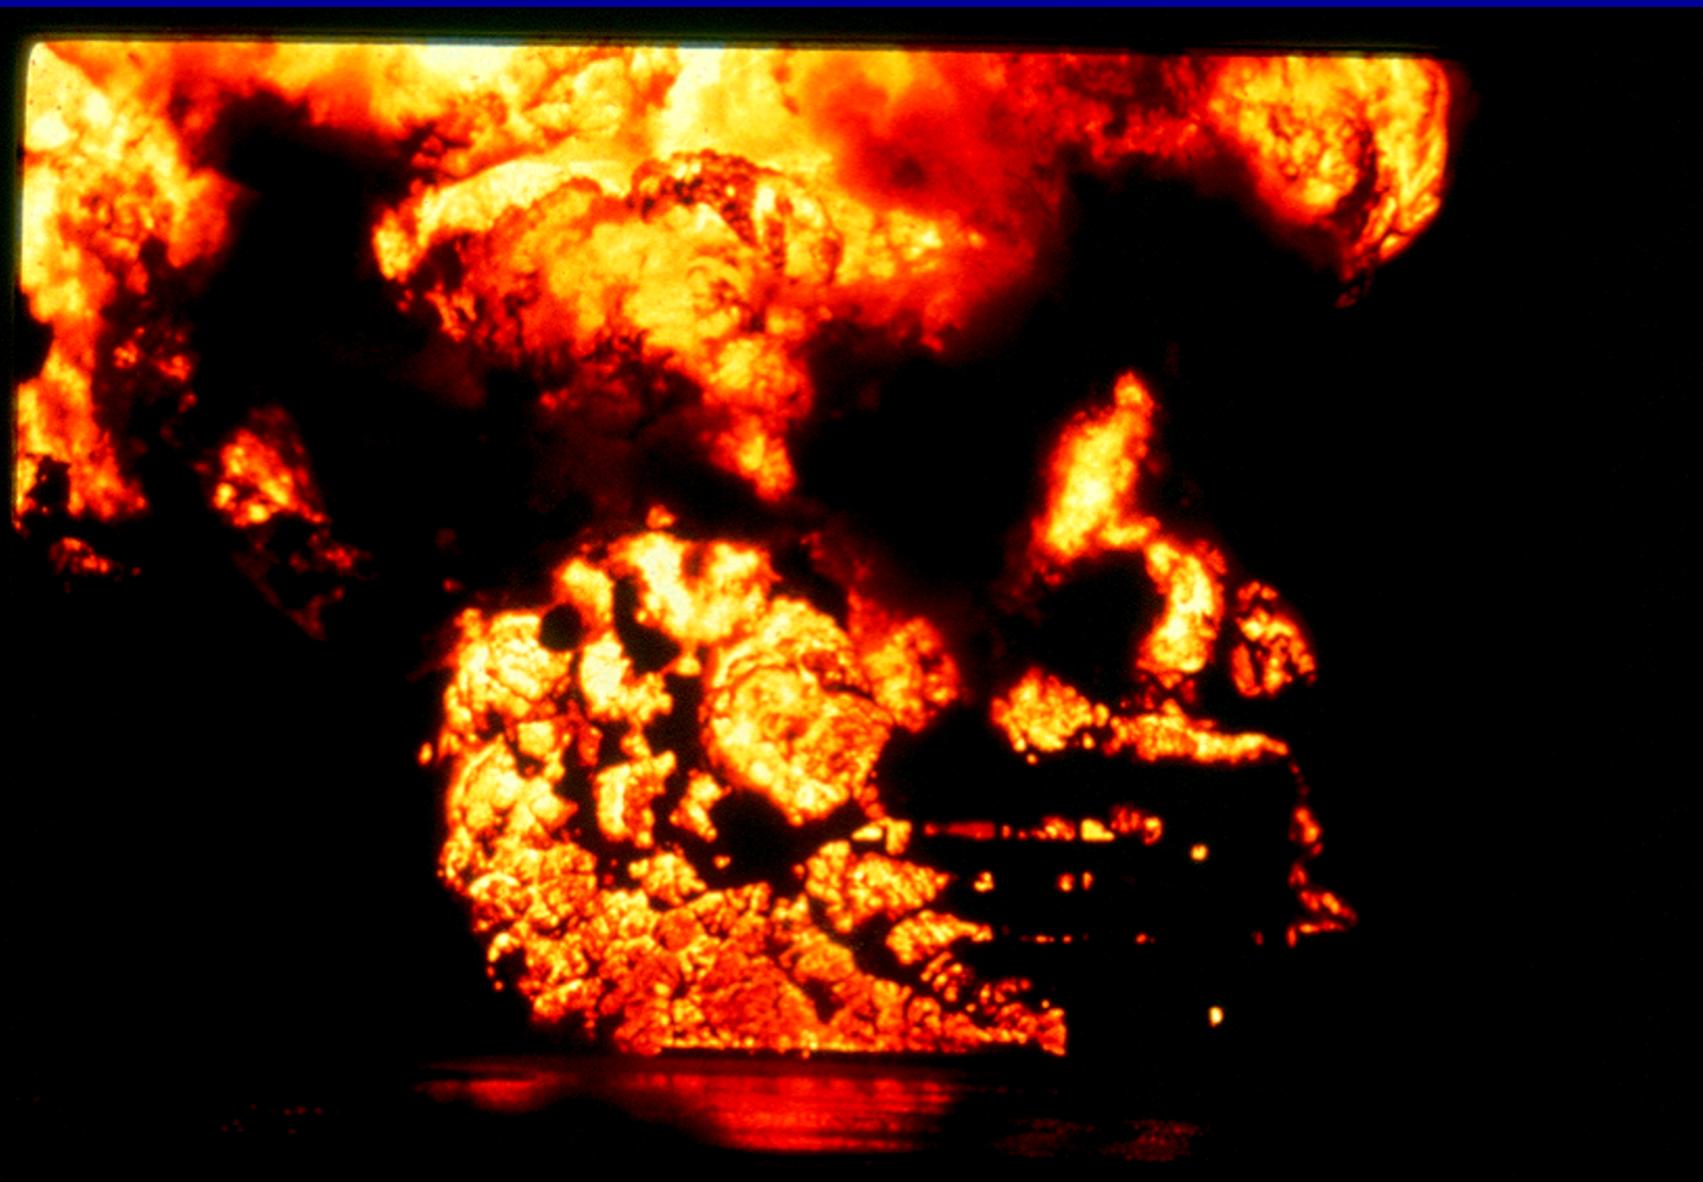
- Sudden gas release through open DEMCO valve – 85,000 lb_m mixture of hydrogen, ethylene, hexene & isobutane
- Unidentified ignition source “found” within 2 min.
- Explosion equivalent to 2.4 tons of TNT
- Second explosion 10-15 min. later:
2 isobutane storage tanks
- More explosions during next 2 hrs.

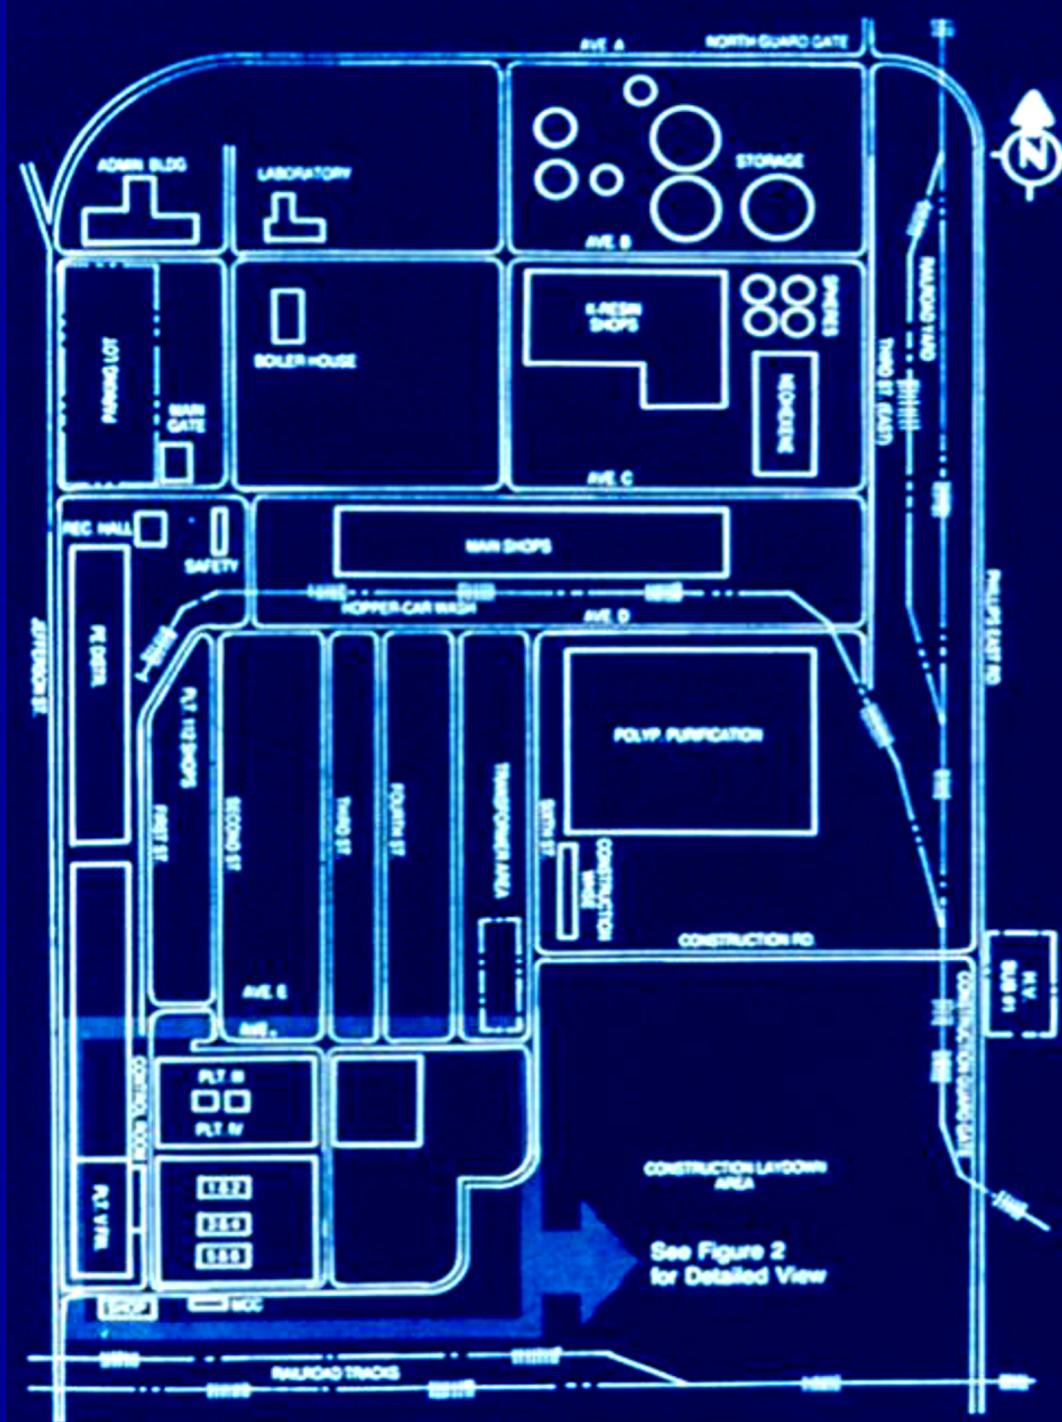
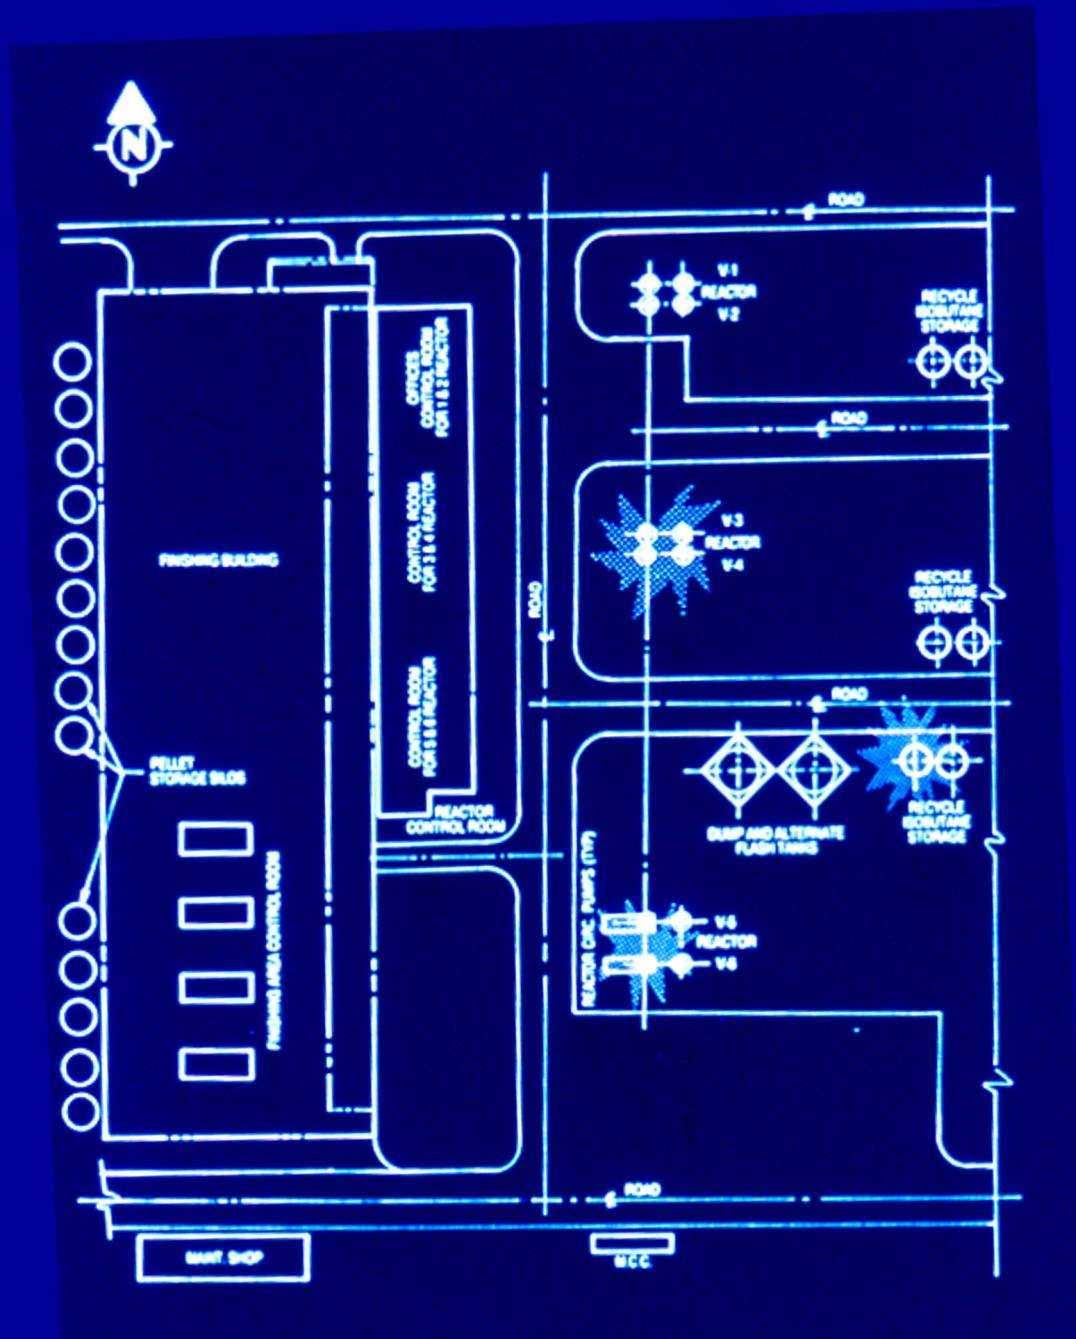
- 23 workers killed: 2 contractor, 21 Phillips
- Debris scattered over 6-mile radius
- 2 polyethylene plants completely destroyed
- Property damage: \$715 million (1/1/93)
- Business interruption loss: \$700 million (1/1/93)
- Disruption of plant fire-fighting water
- Only 1 effective diesel backup fire-water pump

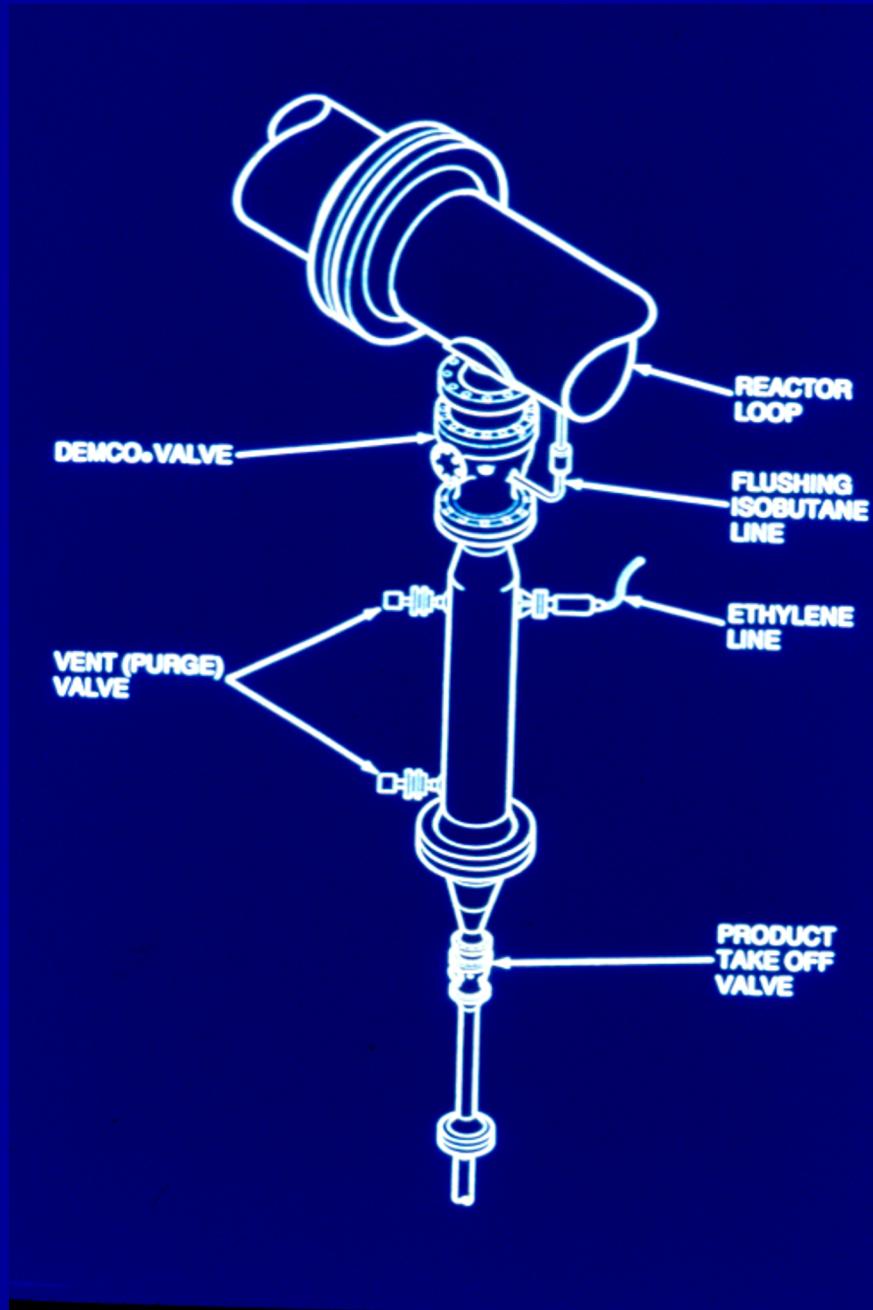
Reactor Settling Leg

- 3 settling legs on Reactor 6 were plugged
- All legs prepared by Phillips operator:
 - ready for maintenance
 - DEMCO valve in closed position
 - air hoses disconnected
- Fish Engineering (maintenance contractor) partially disassembled no. 4 leg
 - extracted polyethylene “log”
 - requested Phillips operator assistance

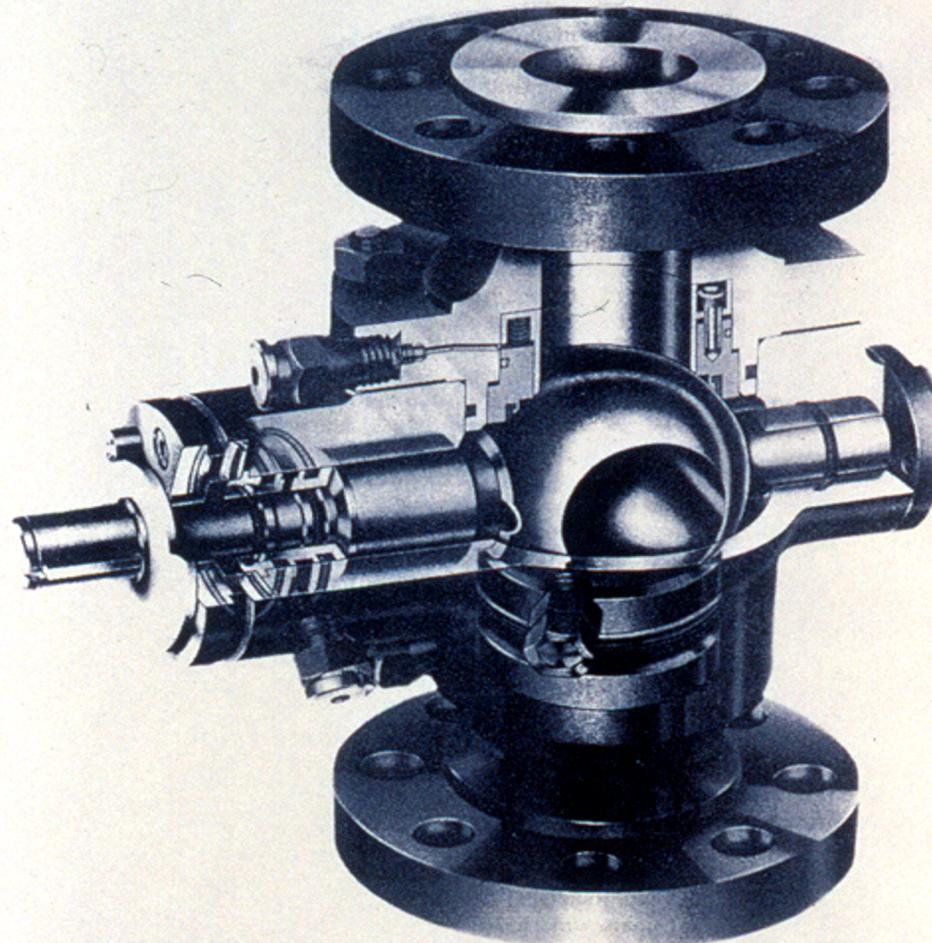
Demco Valve

- DEMCO valve open at time of release
- Air hoses connected in reverse position
- Inadequate valve lockout system
- Local procedures did not incorporate required double block valves or blind flange insert when a line in a chemical or hydrocarbon service is opened

- No lockout device in place on DEMCO valve actuator mechanism
- Air supply hoses could be connected during maintenance
- Identical air hose connectors for “open” and “closed” sides of valve
- Air supply valves for actuator hoses in “open” position

- 2b. No provision for redundancy on DEMCO valves, no adequate lockout/tagout procedure, improper design of [DEMCO] valve actuator mechanism.
3. An effective safety permit system was not enforced with regard to Phillips or contractor employees to ensure proper safety precautions during maintenance.

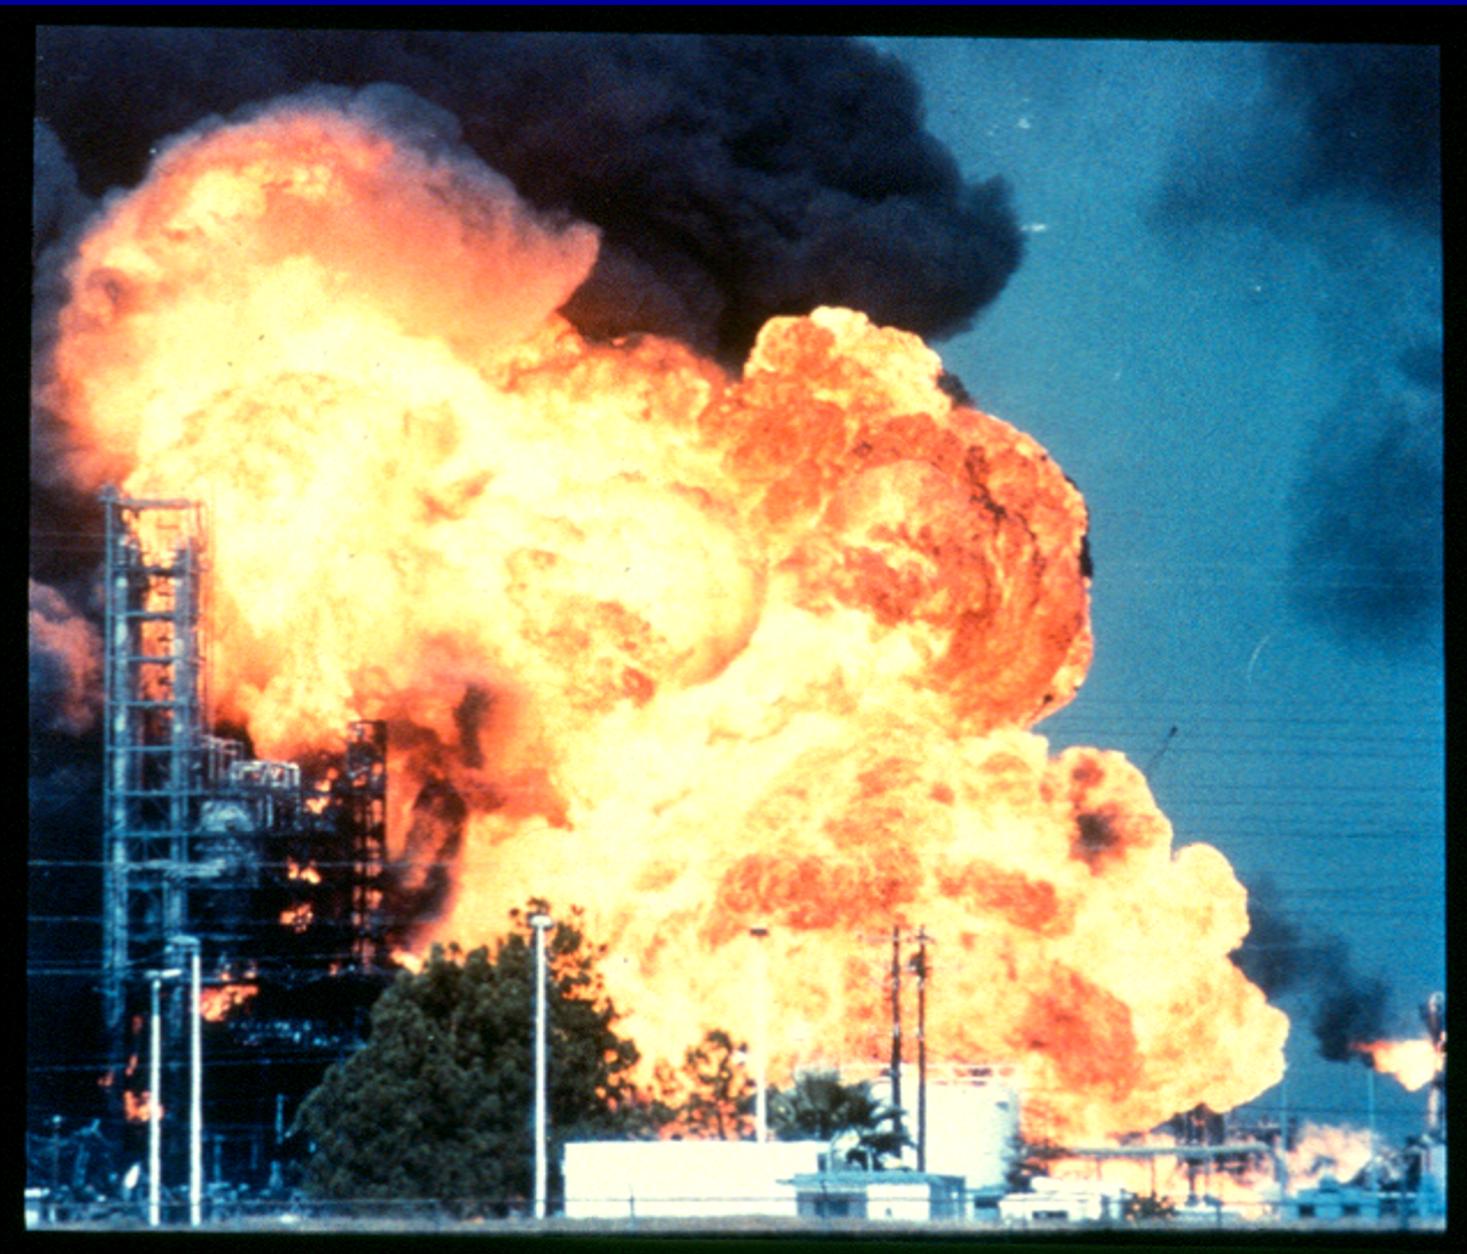
- Ignition within 90-120 seconds
- Second explosion 10-15 min. later: two 20,000-gal. isobutane storage tanks
- Third explosion: 15-30 min. later: another polyethylene plant reactor failed catastrophically

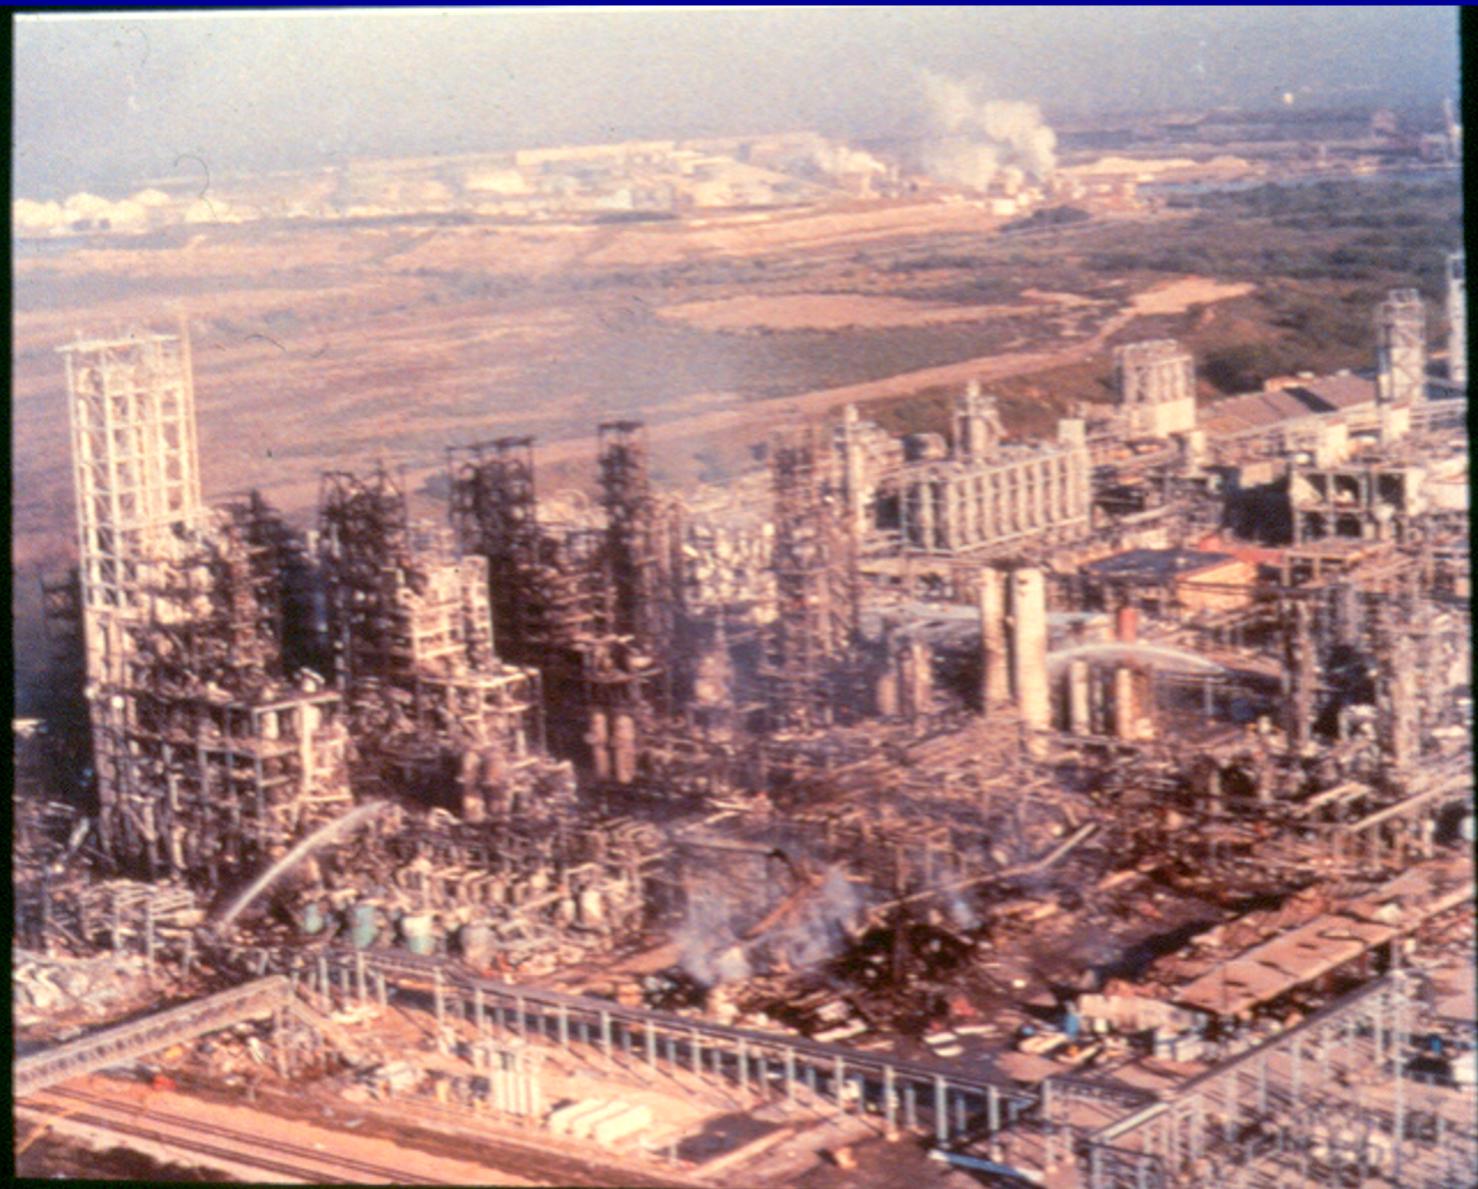
- Common process/fire-fighting water system
- Fire hydrants sheared off by blast
- Inadequate water pressure
- Regular service fire pumps disabled by fire
- Only 1 backup diesel fire pump available
- Hose laid to remote water sources
- Fire control by CIMA members, local fire departments, Phillips foam trucks
- Control within about 10 hrs.
